## **Scope**

A drop test session of the FLIR Ex Pro was done from 2.0 m on sensitive areas of the cameras. The drop surface was four layers of 12 mm (1/2 in.) plywood over concrete.

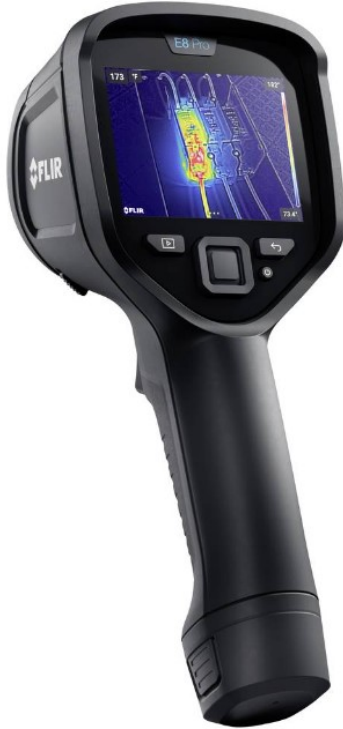
Picture 1: Tested camera model.

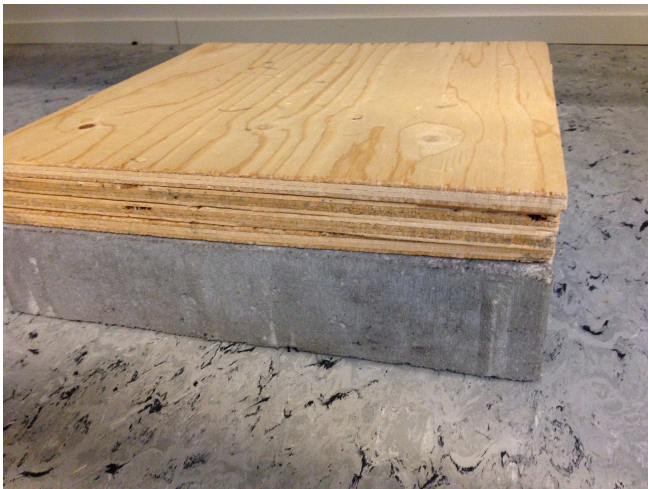
Picture 2: Drop surface.

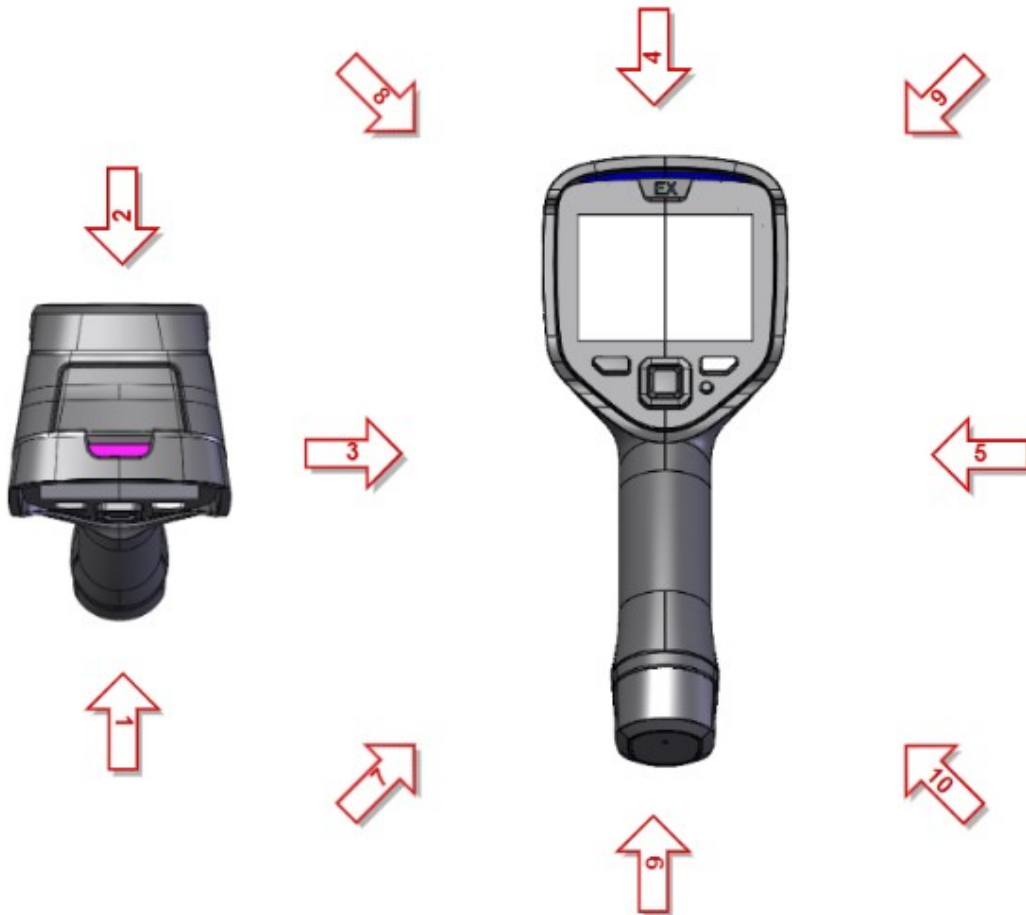
Image 3: Drop directions

Camera\drop nr. (direction)	1	2	3	4	5	6	7	8	9	10	11 (4)	12 (6)	13 (7)	14 (9)	15 (3)
#1	x <sup>1</sup>	x <sup>1</sup>	x <sup>1</sup>	x <sup>1</sup>	x <sup>1</sup>										
#2						x <sup>1</sup>	x <sup>1</sup>	x <sup>1</sup>	x	x					
#3											x <sup>1,2</sup>	x <sup>2</sup>	x <sup>1,2</sup>	x <sup>1,2</sup>	x <sup>2</sup>

\*1 Battery loosened, OK after being reinserted

\*2 Direction randomly selected
