## APPLICATION NOTE

# INFRARED THERMOGRAPHY INSPECTION FOR EXTENDING ASSET LIFETIME AND KEEPING SHUTDOWNS UNDER CONTROL

*FLIR GF309 - An innovative solution to diagnose potential trouble areas of refractory lined equipment and online monitoring of radiant tubes in process heaters.*

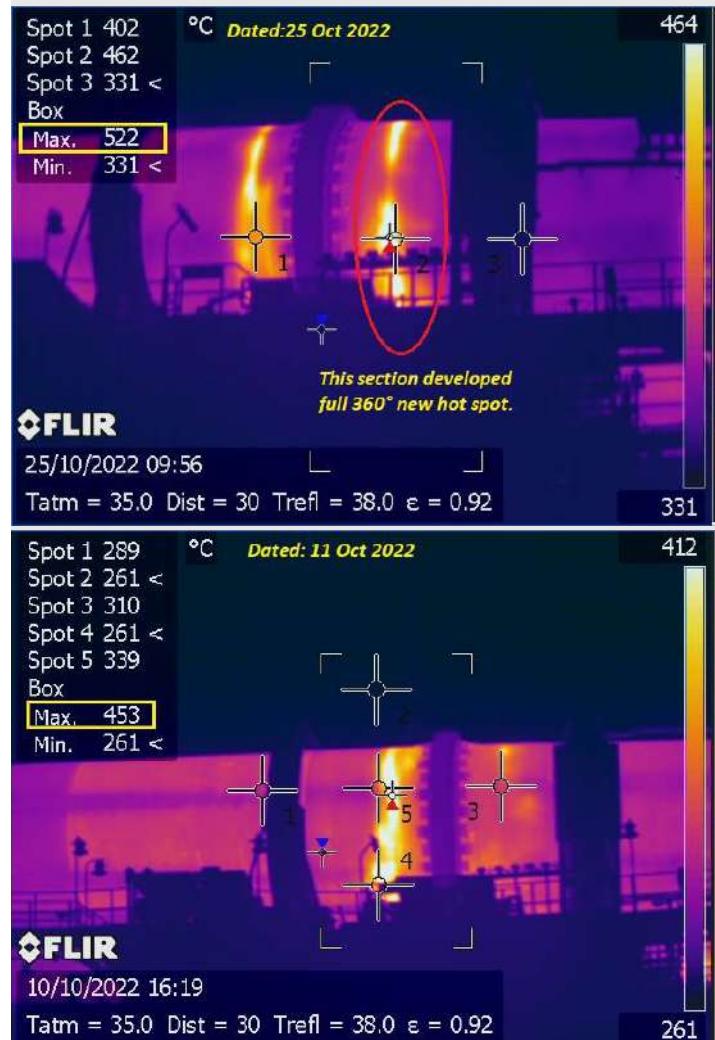
Thermography of Rotary Kiln showing hotspot caused by refractory damage.

After the incident of bricks falling continuously through hot dump area and coke cooler badly blocked with mud and carried over bricks, series of thermography assessment were performed to help gauge the extent of anticipated repair in Rotary Kiln. It was noticed that the damaged section has increased which may be inferred from the images on right side. We found that the previously documented hotspots had greatly expanded. Where before there were only isolated hot spots, now showing signs of widespread refractory failure. It appeared as large number of bricks were now missing throughout circumference of Rotary Kiln allowing greater heat transfer to the outer shell of the equipment.

During unplanned outage, the damage areas observed were perfectly matching with those indicated by thermograms taken in-service.

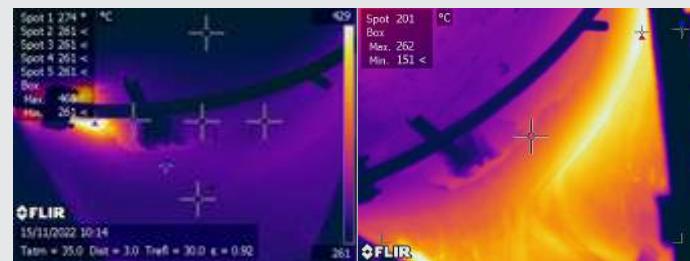
Thermography of Main Reactor-Riser and WYE Design Skin  
Temperature 242°C Observed with hot spot temperature 450~468°C (left). Observed with no hot spot temperature 262°C after repair(right).

Residue fluid catalytic cracking at ADNOC Refining is the world's largest in terms of capacity and has state-of-art technology for the Reactor-Regenerator system. RFCC is used for upgrading heavy feedstocks to light products such as gasoline. During shutdown, for all inspection and maintenance activities on this humongous equipment, which loaded with many cyclones at intricate locations, are extremely difficult to access considering the quantum of scaffolding erection involved. RFCC is a business-critical unit, and each hour of a shutdown counts.

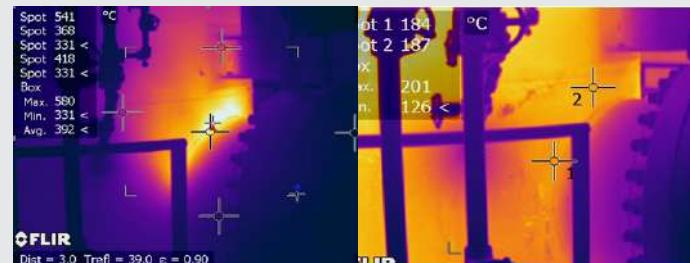
Refractory Lined Equipment Nozzle-Images before (hot spot indication) and after refractory repair (no hot spot indication)

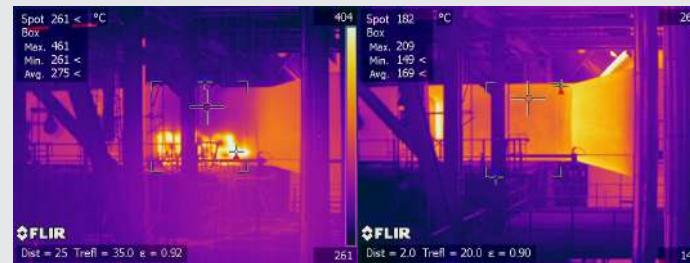
2nd Stage Regenerator Orifice Chamber-Images before (hot spot indication) and after refractory repair (no hot spot indication)

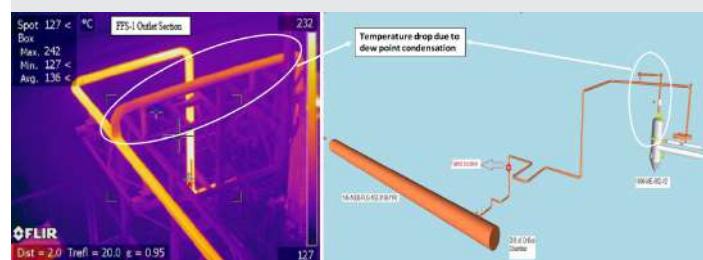
Thermograms helped to identify symmetry and temperature variation concerns in the Fin-Fan cooler and Flue Gas Piping

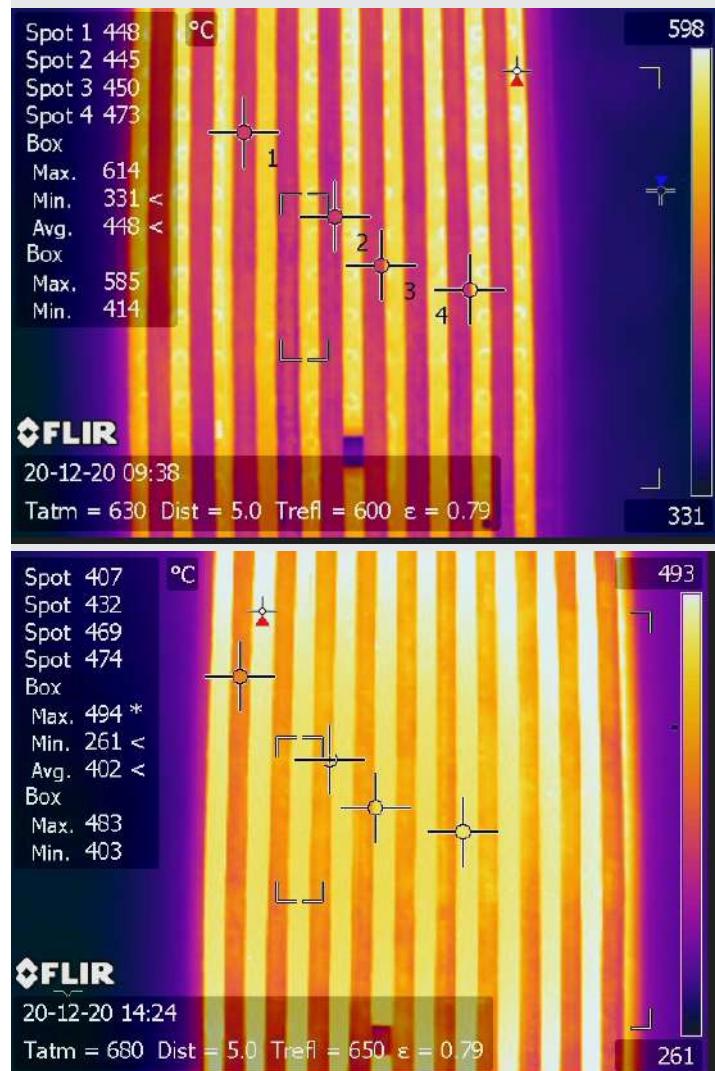
Images of routine infrared surveys for monitoring skin temperature of radiant tubes at Crude Heater in Crude Distillation Unit.

Design Tube Skin Temperature: 474°C

By utilizing a thermography imaging device specifically designed for heater inspections, valuable performance information is obtained to monitor the overall temperature profile of the process heater tubes. Skin temperature indication by thermocouple provides information about the heater tubes only where the thermocouple is welded. Infrared imaging gives information about the entire heating surface of the tubes. In the hands of a knowledgeable engineering team, accurate infrared data can be utilized to significantly increase heater throughput while helping to ensure safe operation of the heater.
